Round Corner Square (RCS)
Bloom,
Wheel and Axle (WAP) Grade
Steel for Railways,
Non-metallic Inclusion,
Decarburization,
SEM-EDAX

Received: September 8, 2016

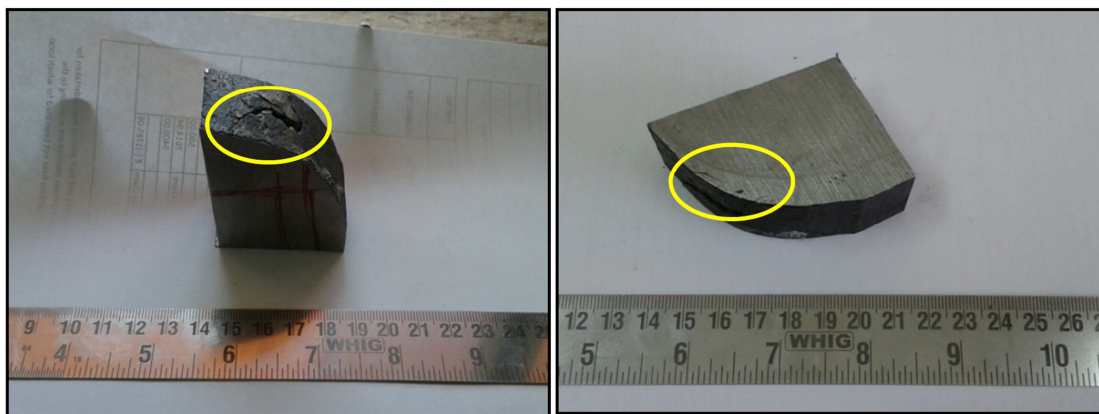
Fig. 1. Visual appearance of the surface crack in WAP bloom sample (Sample portions subjected to optical microscopy and SEM-EDS observation and analyses are circled).

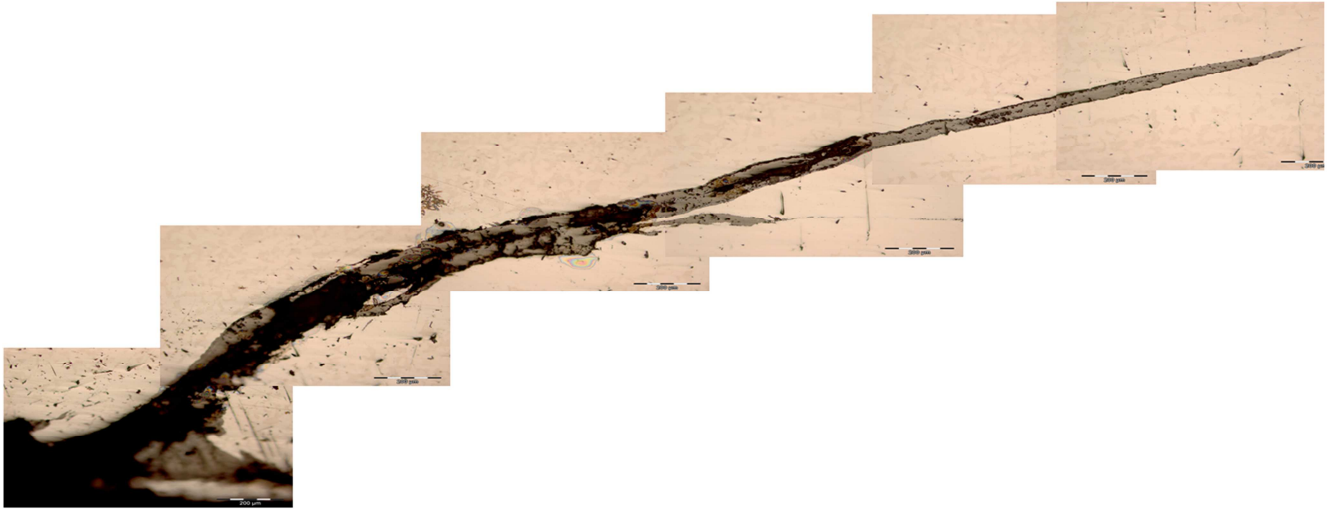
Fig. 2. Light optical micrograph of the cracked bloom sample showing a curvilinear, long, tapering crack extending from sample surface to interior replete with fragmented oxide scale debris.

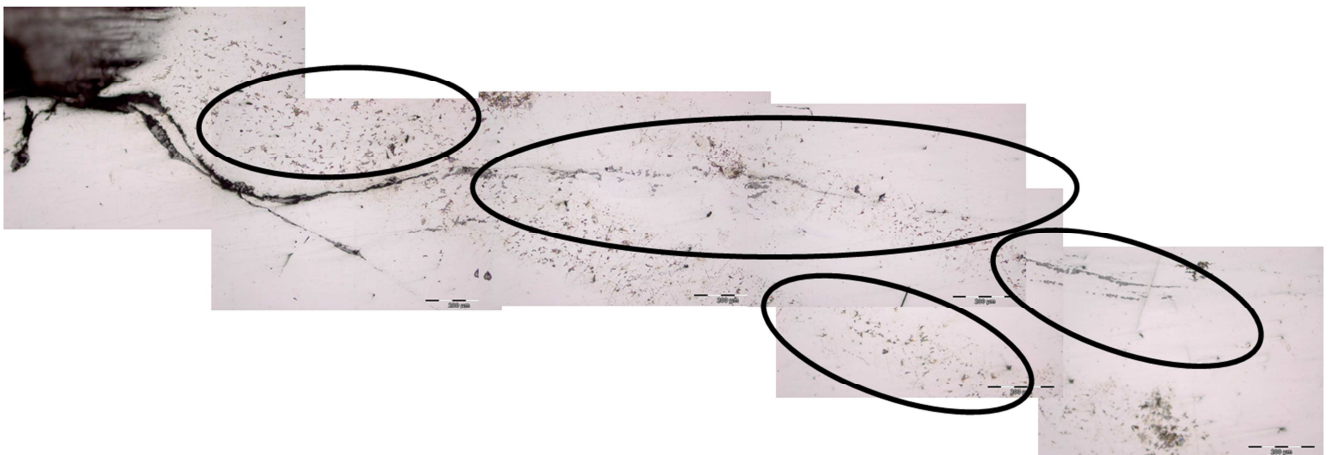
Fig. 3. Light optical micrograph of the cracked bloom sample showing a fine, curvilinear, tapering and branched crack filled with fragmented oxide scales and a preponderance of subsurface entrappings/ inclusions (circled).

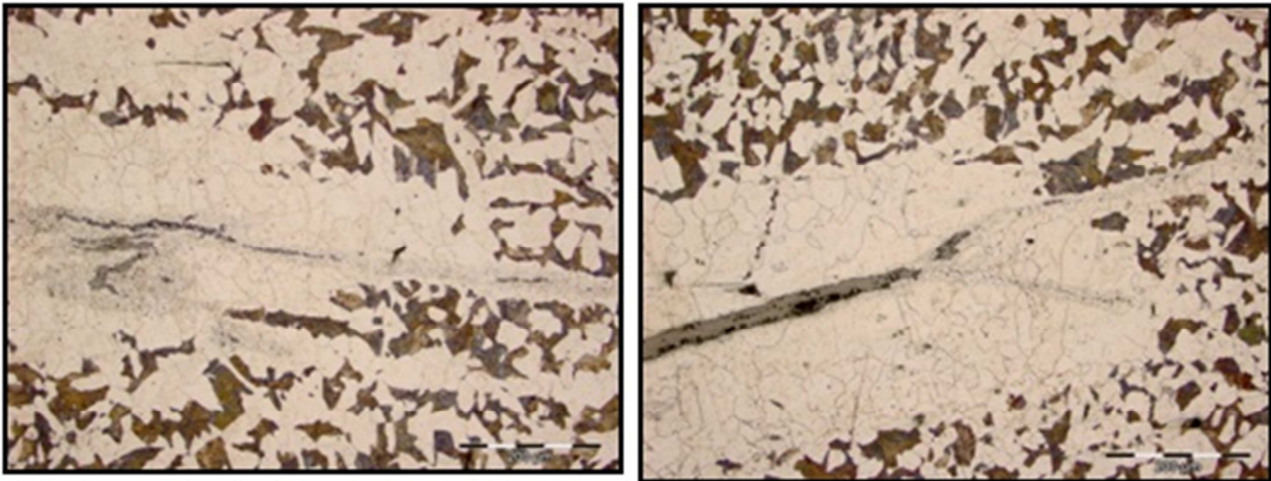
Fig. 4. Light optical micrographs of the bloom sample showing various magnified views of the crack with extensive decarburization and evidences of grain coarsening adjacent to the crack surfaces along with associated entrappings/ inclusions in as-etched condition.

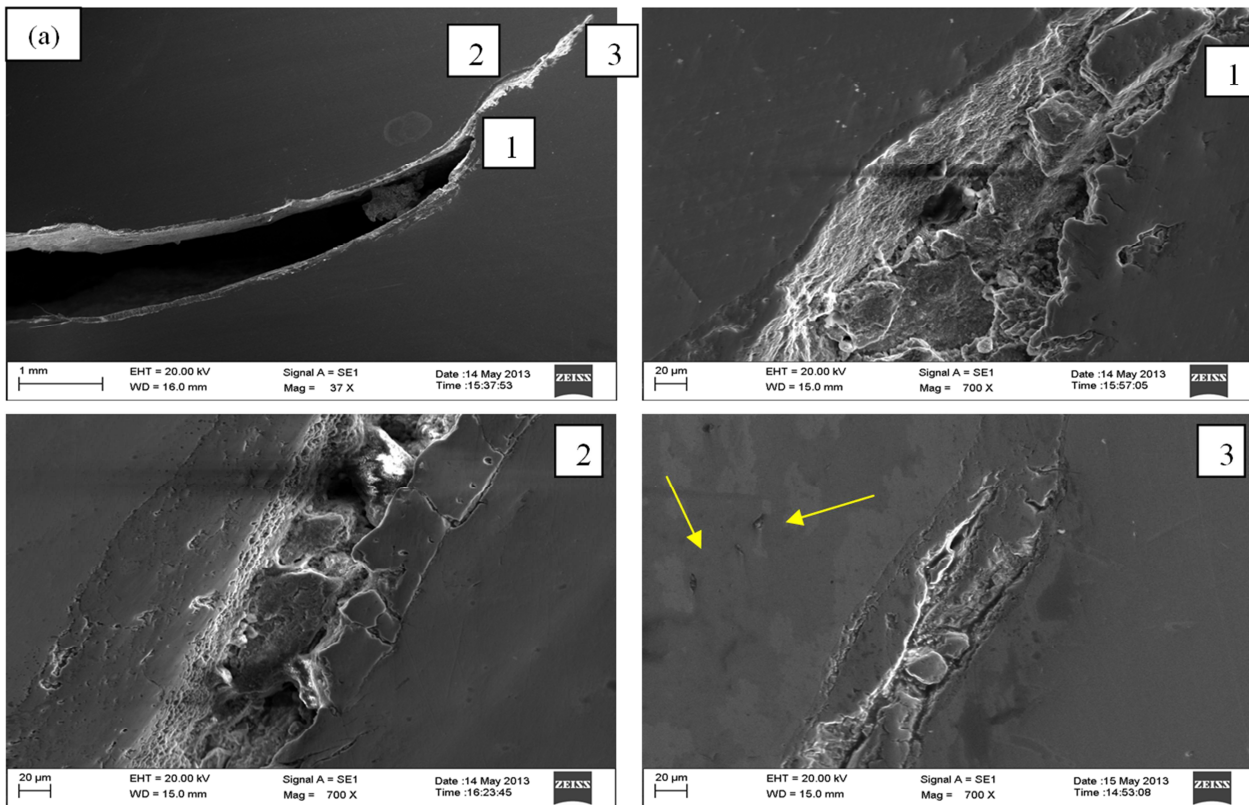
Fig. 5. Secondary electron images of the (a) crack RCS bloom sample and (1, 2 and 3) magnified image of crack [image of (a)] exhibiting crack filled with fragmented oxide scale debris and associated with massive entrapment in as-polished unetched condition.

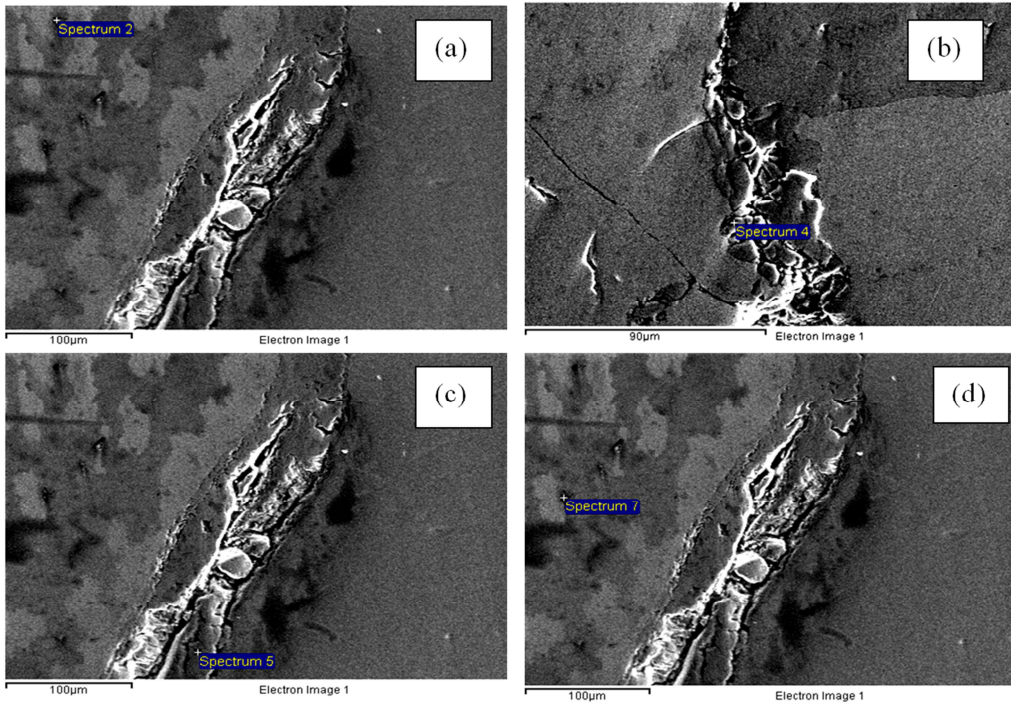
Fig. 6. SEM analysis performed at various locations at vicinity of the crack in as-polished unetched condition.

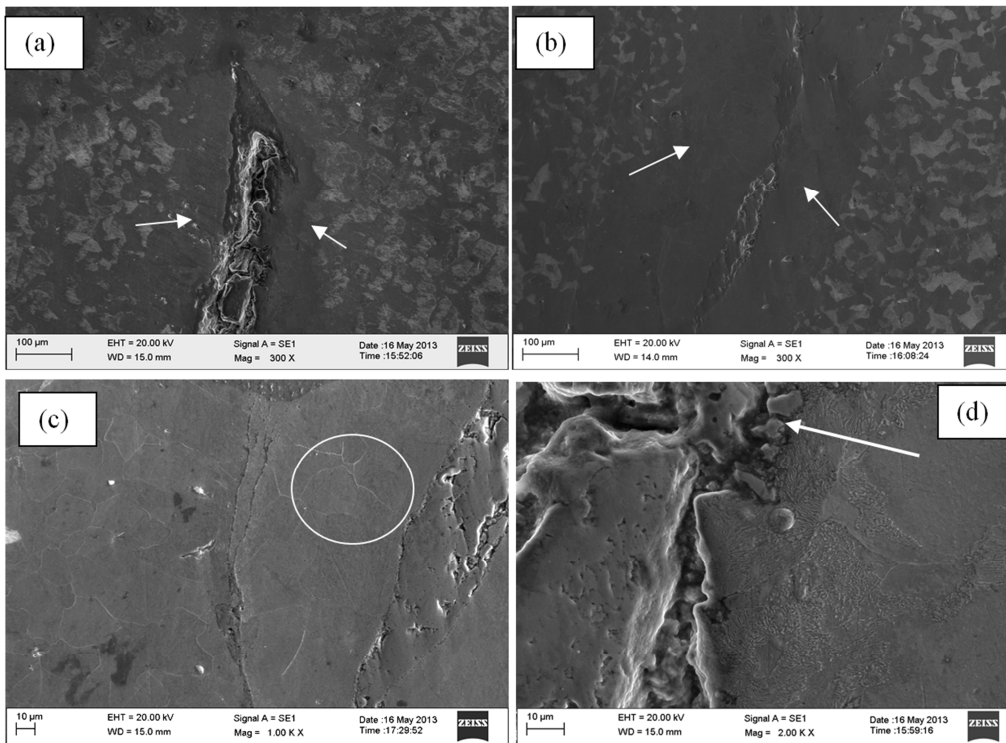
Fig. 7. Secondary electron images of the cracked bloom sample showing various magnified views of the crack with (a and b) extensive decarburization and (c) evidences of grain coarsening adjacent to the crack surfaces along with associated (d) entrapments of oxide scales and inclusion.

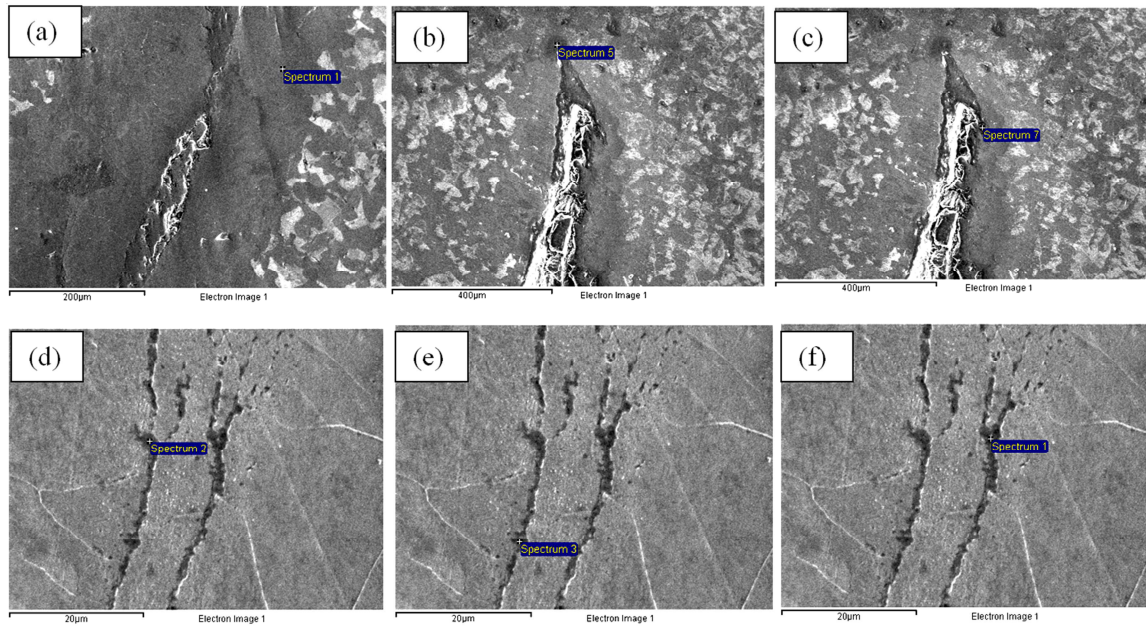
Fig. 8. Image of SEM and EDAX analysis performed at various locations at the vicinity of crack defects showing extensive decarburization and evidences of grain coarsening at the crack surfaces in as-etched condition.
