Study of Stability of the Slope of Access to the Viaduct of Wadi Dib, Northeast Algeria

Riad Benzaid*, Mustapha Tekkouk

Riad Benzaid, Mustapha Tekkouk. Study of Stability of the Slope of Access to the Viaduct of Wadi Dib, Northeast Algeria. *American Journal of Civil and Environmental Engineering*. Vol. 2, No. 3, 2017, pp. 21-29.

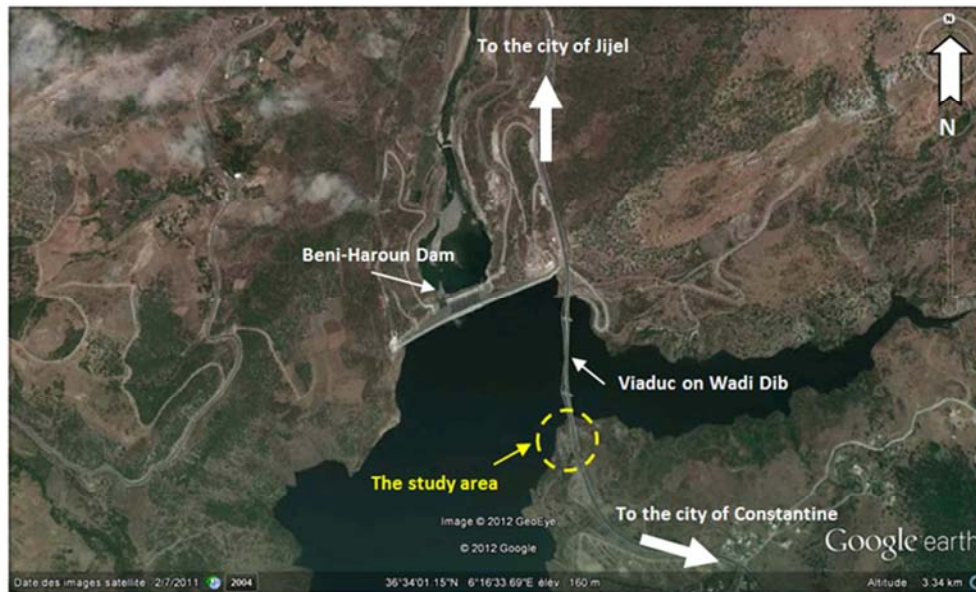
Figure 1. Location of the viaduct and the study area.

The land object of this study is located to the North-West of the city of Grarem Wilaya of Mila (Figure 1 and 2). From a morphological view point the site is characterized by irregular topography with slopes whose acceleration is variable. From a geological view point, the small valley of Wadi Dib that is crossed by the bridge (achieved already) is composed by the soils of clayey sedimentary nature to the center and rocky to flanks, these flanks have a thickness of 80m in relation to the bottom of the small valley.

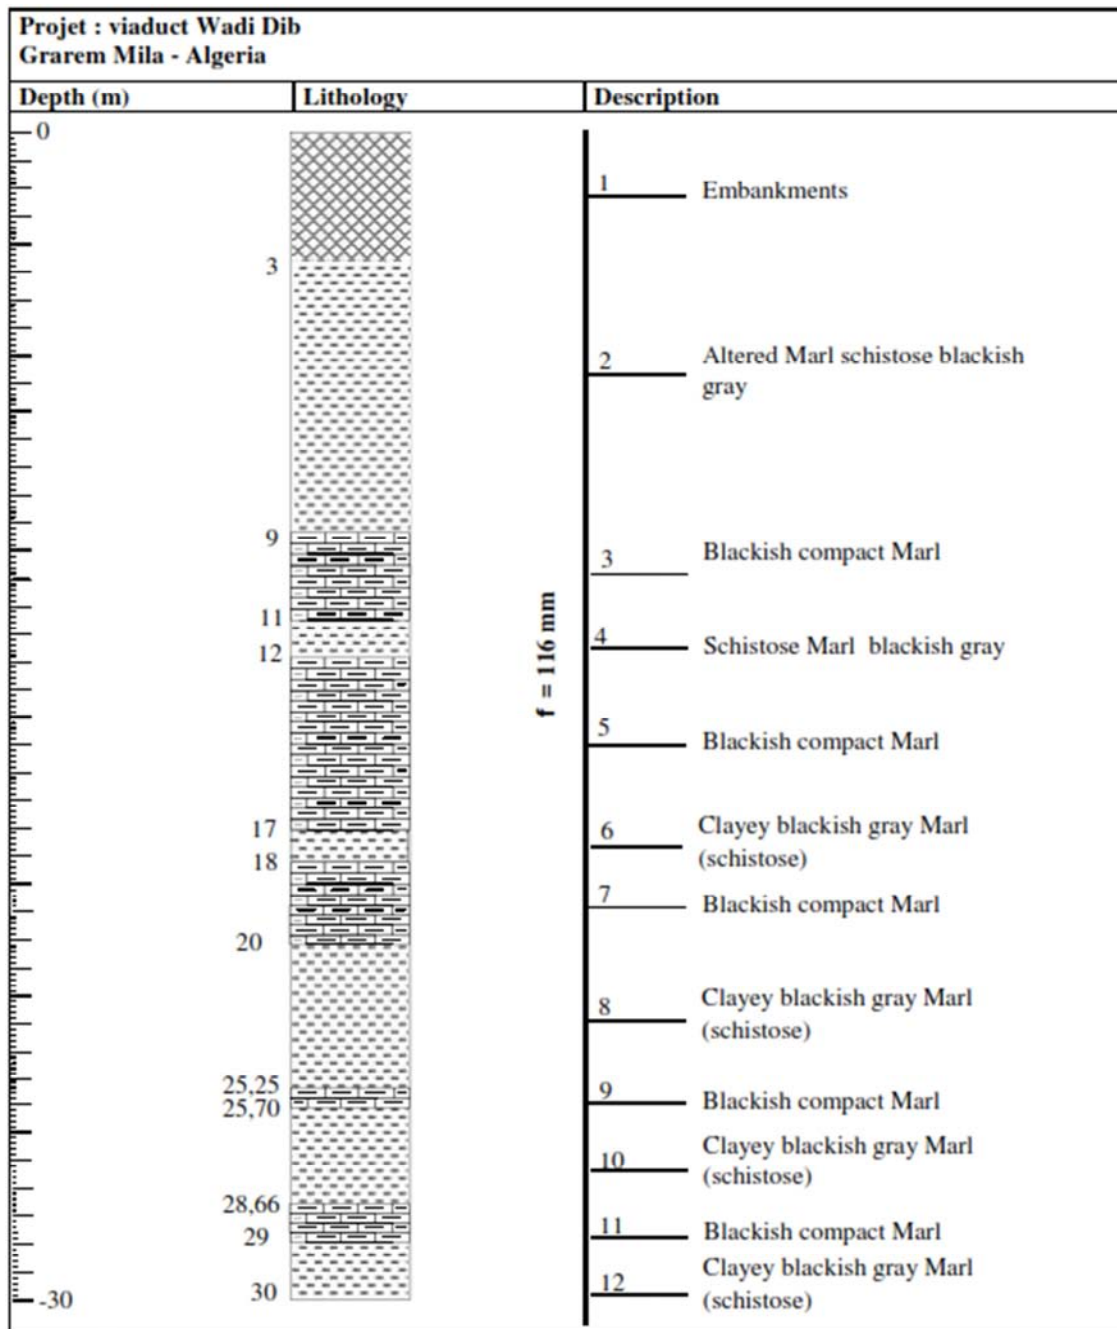
Figure 3. Typical field boring log N°05.

The dip of layers of the marly-limestone is the order of 45° N-W for the south side of the small valley and 35° S-E for the North side. The central part is constituted, in surface, by alluvial deposits and in depth by an alternation of layers more at least affected by the tectonics. With regard to the mechanical parameters of these layers they improve with the depth, until to reach values of compacted rocks. Lands of the structure work are formed essentially of limestone, marly-limestone, marl, clay and embankment. To put in evidence this lithology one takes the core sampling that contains all existing layers of our site (Figure 3) [14-16].

Therefore two lithologic formations have been raised, it is about:

- a. Limestone: they are grayish and are greatly fractured.
- b. Marls: - Marl blackish gray, they are often clayey and also present a schistose aspect.
- c. Blackish Marl compact (marly-limestone): they are indurate to compact.
