Intelligent Vision Based Driver Assisted System for Trains – Elephants Accidents

A. K. Kulatunga, J. Gowryathan, R. Ekanayake, D. Athauda, C. Chandrakumar

Department of Production Engineering, Faculty of Engineering, University of Peradeniya, Peradeniya, Sri Lanka

A. K. Kulatunga, J. Gowryathan, R. Ekanayake, D. Athauda, C. Chandrakumar. Intelligent Vision Based Driver Assisted System for Trains – Elephants Accidents. *International Journal of Electrical and Electronic Science*. Vol. 2, No. 2, 2015, pp. 6-16.

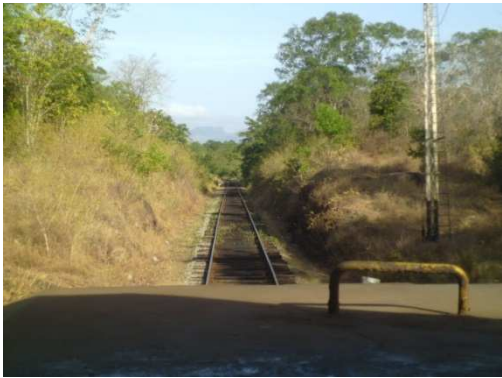
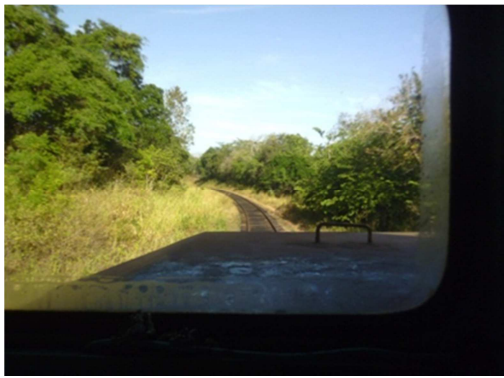
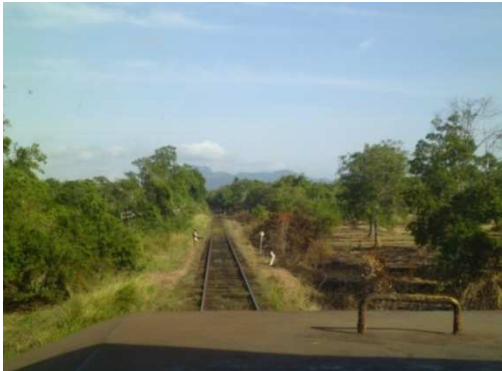
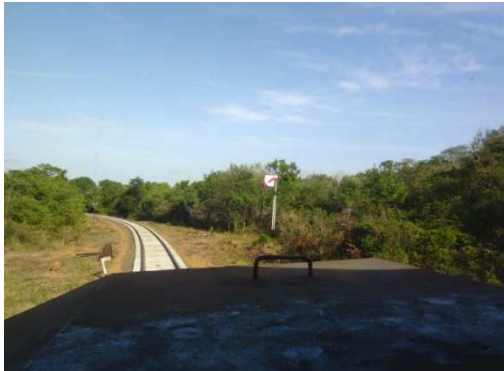
Figure 2. Site specific visibility problems.

Earth cuts

Grown vegetation

Embankment

Sharp curves

poor maintenance. In addition, many use to complain that intensity of head lights also not adequate to sight the elephant at a reasonable distance to avoid accidents and sharp curves available in some sections. When visibility is concerned, it can happen due to two reasons: due to the outside aspects or inside aspects [8]. The outside aspects are considered the reasons for the lack visibility from the surrounding of the track such as vegetation besides tracks, sharp curves, (Shown in Figure 2), trapping of elephants between the earth cut and on embankments when train arrives, and the inside aspects are from locomotive itself such as locomotive cab arrangement, positioning of driver seat and most importantly the angle of visibility depend on the type of locomotive and intensity of head lights (shown in Figure 3). In addition to the site specific and cab specific problems there is another reason which attracts wild elephant closer to the railway tracks [9]. That is due to passenger's irresponsible behavior of throwing food garbage out of the windows by the sides of the tracks.

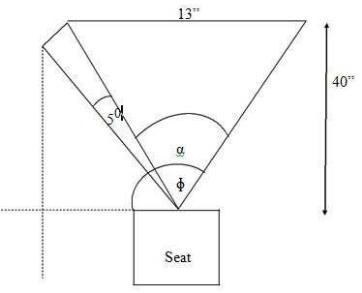
Calculation	$\tan(\alpha/2) = a/2b$ $\tan(\alpha/2) = 0.1625$ $\phi = 90 + (\alpha/2)$ $\Theta = 90 + (\alpha/2) - 5$	$\tan \phi = 21 / (2 \times 40)$ $\phi = 15$ $\alpha = 90 + 15 = 105$ $\Theta = 105 - 5$ 100^0	$\tan \phi = 17/43$ $\phi = 22$ $\alpha = 5$ $\Theta = \phi + 60^0 - \alpha$ 77^0
Angle of visibility (Θ)	95^0	100^0	77^0
Percentage of visibility (%)	52.77	55.55	42.77

operation of locomotive was tested. Since we could not find any previously used approach for similar type of analysis, we defined visibility angle and relative visibility percentage as shown below;

Visibility = $(\Theta \times 100\%) / 180$
