American Journal of
Environmental
Engineering and Science

Flood vulnerability assessment and disaster risk reduction in Kubwa, Federal Capital Territory, Nigeria

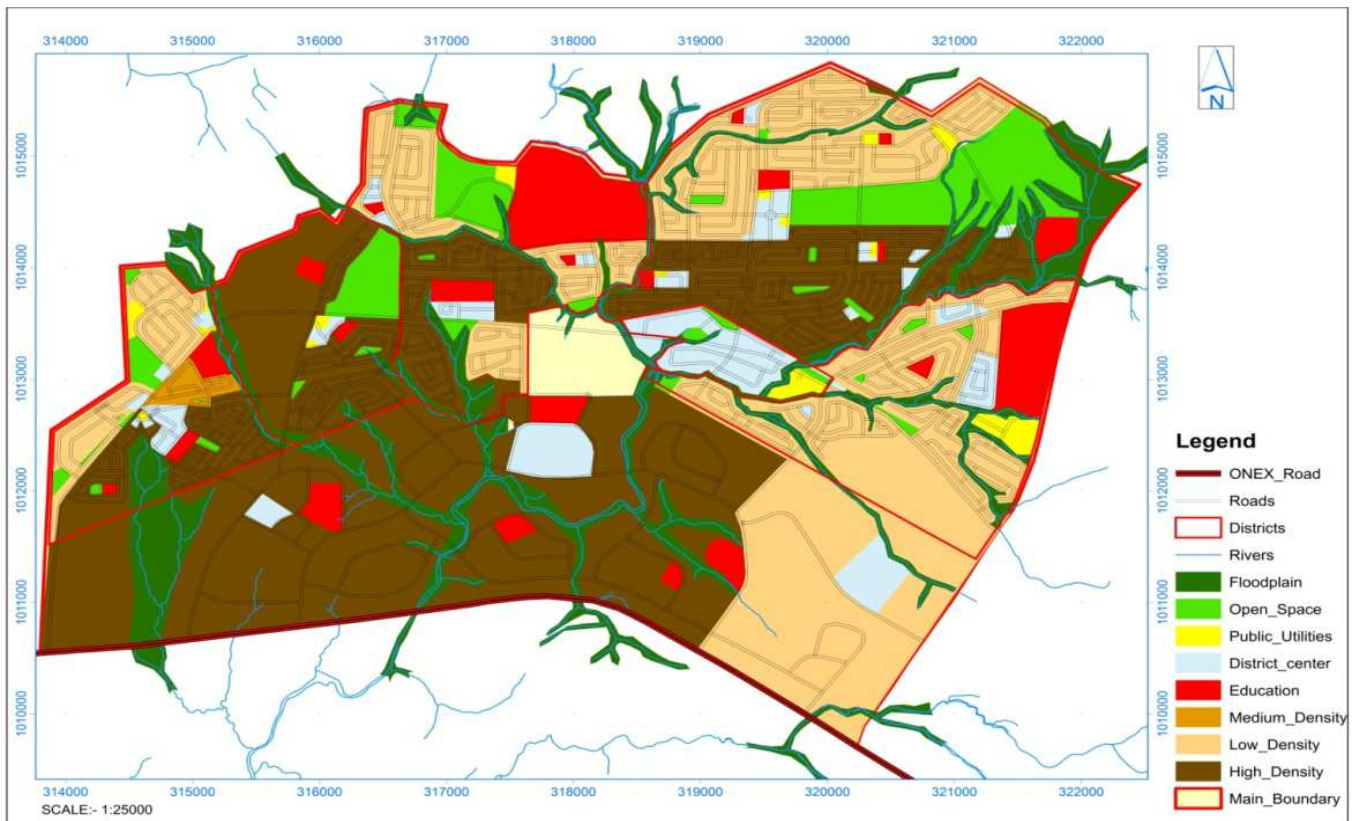
Figure 1. Landuse map of Kubwa Settlement Source: Fola Konsult Nig. Ltd, 2004.

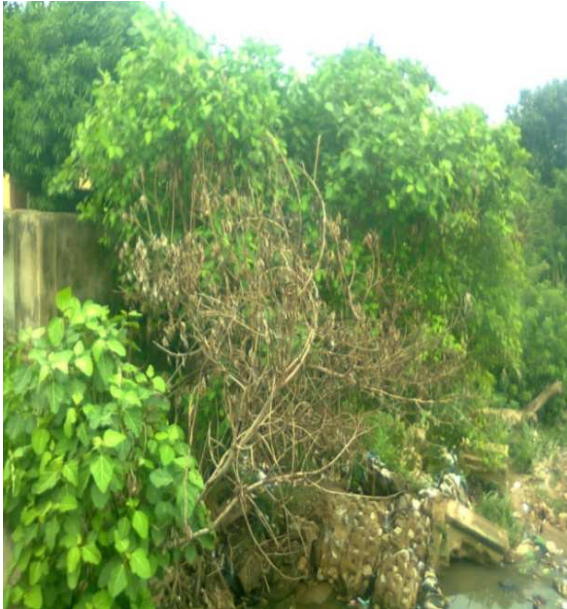
Plate 1. Building's fence in the river at phase 3

Plates 2 and 3 shows buildings along Phase 3. The fence of the buildings encroached on a river and the fact that the house was marked for demolition by virtue of its location on the floodplain. These encroachments may result in a high probability of loss of human life, will likely cause future damage that could be substantial in cost or extent, including interruption of service or loss of vital transportation facilities, or will cause a notable adverse impact on natural and beneficial floodplain values. Figure 11 shows a building within the flood plain and some within the 30m buffered zone.

interpreted as encroached into the floodplain areas. There were lots of encroachments on ground as identified by the researcher during the Ground Truthing exercise, these includes buildings as well as fences of buildings as shown in plates 1 and 2 in Phase 3 and Phase 2/1.

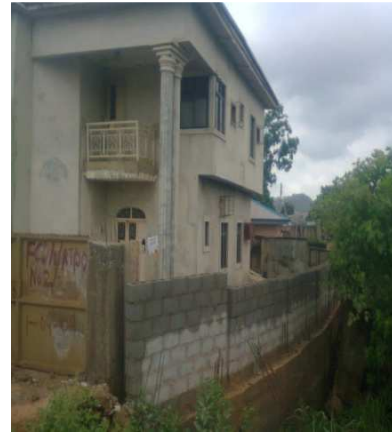
Plate 2. House encroaching on the river at phase 2

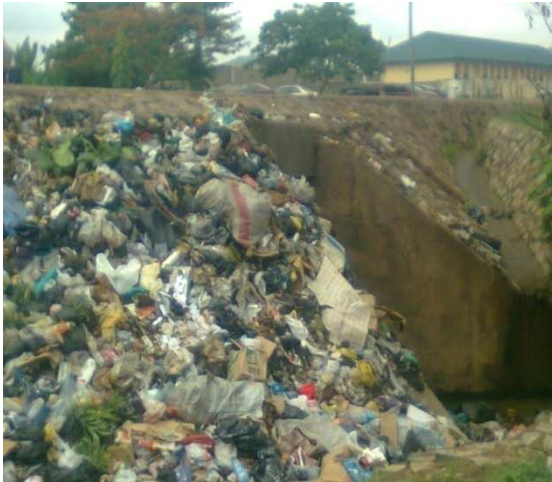
Other means of disturbance of the smooth flow of floodwater is clogging of the drainage with debris. Plates 4 and 5 show refuse dumps at the edge of a bridge by Phase 3; and along a river channel at Gado Nasco in Phase 2/1 respectively. During the recent 2010 and 2012 flood, the bridge was blocked, with water submerging the surrounding areas including the road and all other available space.

Plate 3. Debris by the bridge edge along phase 3.

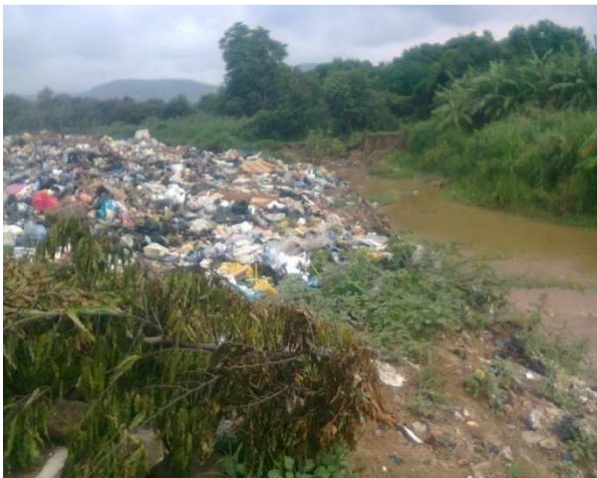
Plate 4. Debris along floodplain by Gado Nasco phase 2/1
