Bacterial Decay of Wooden River Moorings After 75 Years in Service

This study provides some information about the degree of bacterial degradation in pine waterside structures that have been in service for 75 years in running fresh water. It was revealed that 71% of pine heartwood samples were damaged to a weak or moderate degree and 5% were degraded severely and, therefore bacterial degradation of wood in anoxic conditions was underestimated before. The results proved the idea that water movement in the waterlogged structures is a key factor that stimulates bacterial wood degradation. The obtained patterns of bacterial degradation throughout the whole length of a mooring beam showed that head beams can be regarded as a representative of the whole element. It was concluded that the mooring beams under consideration can serve for at least 50 years more.

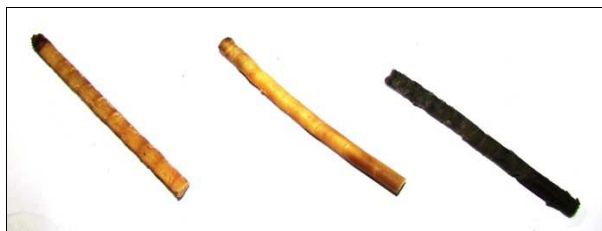
Figure 1. Cores taken at the beam head (right), in its middle part (central) and its foot, near the ground (left).

As in all samples the bacterial decay increases from the pith to the bark side, 49 samples were taken from this waterside structure (from the side facing water) in a radial

direction from the outside toward the centre of the beam with a hand-driven increment borer (Ø5 mm) (Fig. 1).

Cores were taken from beams below the beam head, in its middle part and at its foot. Each core was sealed, together with some river water, in a plastic tube and sent to the laboratory where wood anatomical structure and degradation patterns were studied.

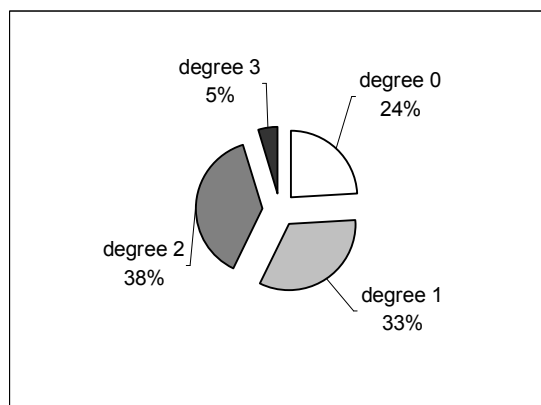
Figure 2 illustrates the observed degree of bacterial degradation of the samples. Twenty four percent of them have no damages in cell walls.

Figure 2. Degree of the bacterial degradation for the beams.

Degraded ray cell walls and parts of isolated late wood tracheids are observed in longitudinal sections for thirty three percent of samples. For these samples in some early wood tracheids cell wall with small eroded grooves (“V” shaped

notches) are detected and the degree of destruction is classified as a weak one (1st degree).

Unexpectedly large amount of samples – thirty eight percent are damaged moderately (2nd degree according to R. Klaassen, 2008). Isolated degraded cells are preserved in a matrix of sound cells with a higher intensity round the rays. Early wood tracheids have grooved-like eroded areas. Whereas the border between sound and degraded cell-wall parts is sharp.

Only five percent of samples are severely damaged (see Fig. 2). In these samples isolated sound cells are observed in a matrix of degraded cells, almost all tracheid cell walls are fully eroded and filled with amorphous residue material. Early tracheid cell walls are fully eroded in grooved-like pattern following more or less the micro-fibril angle.

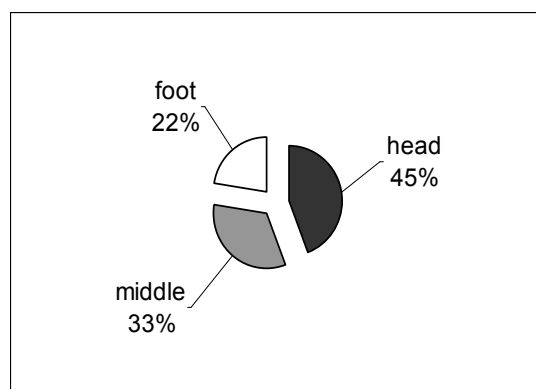
The beam heads are damaged to a greater degree comparing with foots and middle parts (Fig. 3). Severely damaged samples are also taken in the beam head zones. It can be explained by the fact that the river water level changes and those parts of the mooring could stay in dry conditions for some period of time. Probably oxygen, which could be available in this case, can be considered as a trigger for bacterial degradation. The obtained results are inconsistent with the data obtained by R. Klaassen (2008) for wooden piles which were degraded by bacteria over their full length with no observable gradient across pile length. However, local higher degradation intensities across the pile length can be explained by lower water flow velocities close to the bottom of the river (Schmidt, 1980, Klaassen, 2005).

Figure 3. Location of revealed damages in the head, middle and foot parts of the beams.

The results presented in this paper suggest that the status of the beam head, in terms of degradation assessment, can be regarded as the representative of the whole element. This is important for regular inventories.

The study made on the pattern of bacterial degradation throughout the whole length of a mooring beam showed that head beams are damaged to a greater degree comparing with the rest of the beam. Its condition can be regarded as the representative of the whole element.
